**Low-energy, in-situ refurbishment and building performance evaluation of a historic town council building**

# Low-energy, In-situ Refurbishment and Building Performance Evaluation of a Historic Town Council Building

Professor Rajat Gupta  
Dr Adorkor Bruce-Konuah  
Adrian Kite  
Alex Towler  
Nicole Lazarus  
Sue Mackrell

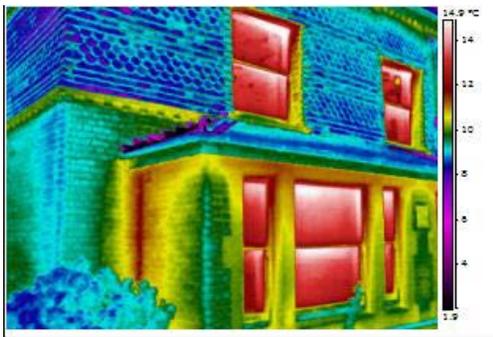
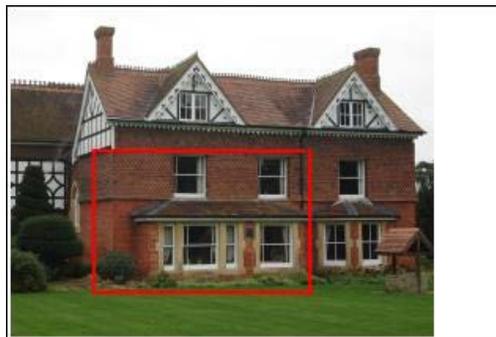
Figure 3 Southwest elevation showing significant heat loss through windows and heat loss through the wall junction

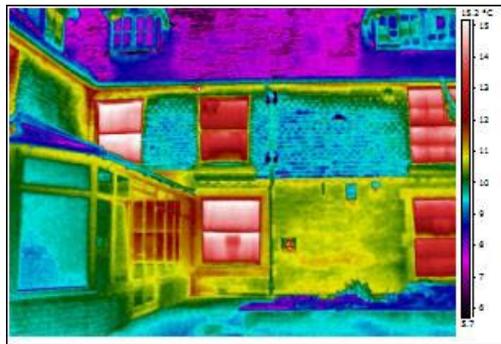
Figure 4 East elevation showing heat loss through the external wall at ground floor which is potentially due to poor insulation of the external wall

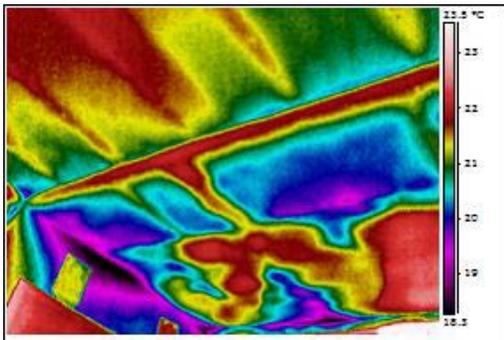
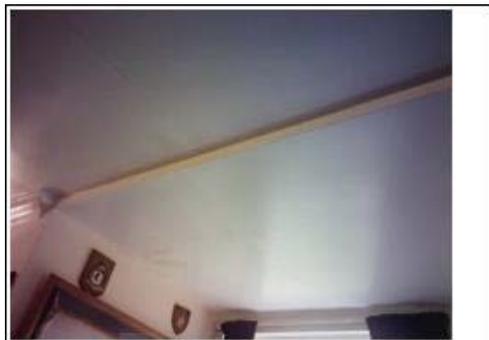
Figure 5 Ground floor room showing thermal anomalies on the ceiling which is potentially due to poor insulation of the pitched roof above the windows

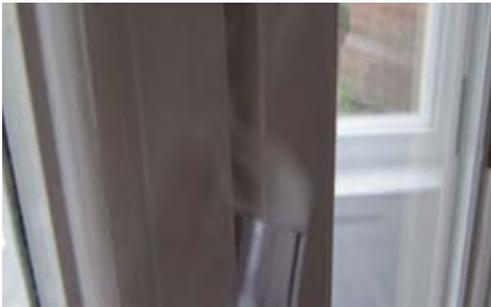
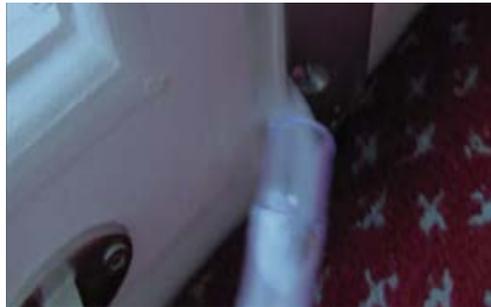
Following the air-tightness test, a smoke pencil survey was carried out in order to identify specific areas of leakage. On the ground and first floors, air leakage paths into the floor void were identified. These occurred around door frames, skirting boards and in rooms where the floor boards were exposed. Regarding secondary glazing, the seal between openable doors was often not in contact with the adjoining door and often the seals stopped short or the tops and bottoms, leaving a gap. The secondary glazing frame did not always

seem to be sealed to the floor and air was drawn under the frame. On the first floor, air was drawn under the floor around the perimeter of most of the rooms. Figures 11 and 12 show some of the identified air leakage paths during the smoke pencil tests.

Figure 11  
Smoke drawn around  
the secondary glazing  
seals

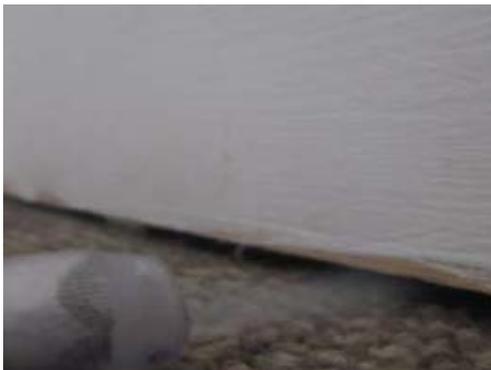
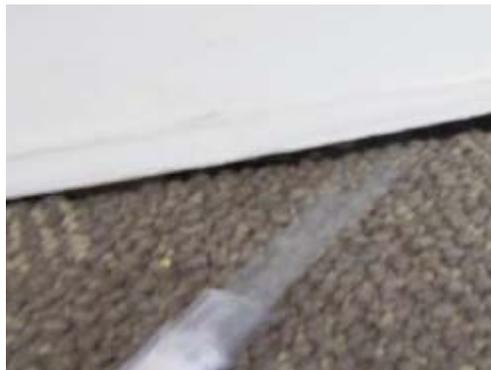
Figure 12  
Smoke drawn through  
the gap between the  
floor and the skirting  
board

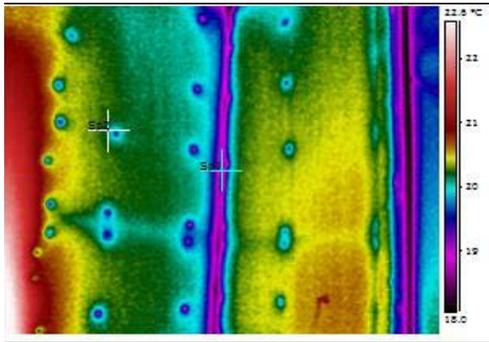
Figure 15  
Office in first floor: the red spot on the ceiling is the air outlet for the MVHR system

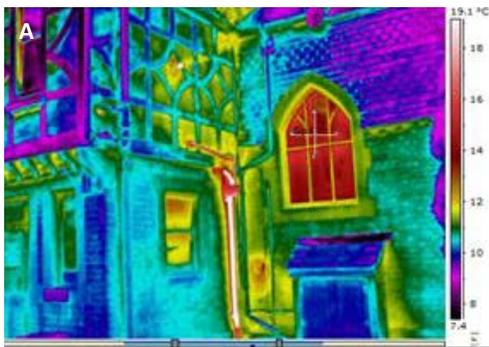
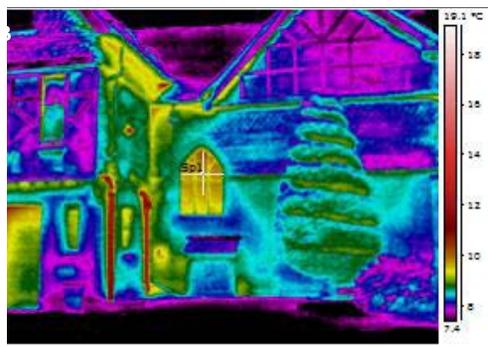
Figure 16  
Thermal image showing heat loss through the window (A) Pre refurbishment (B) Post refurbishment

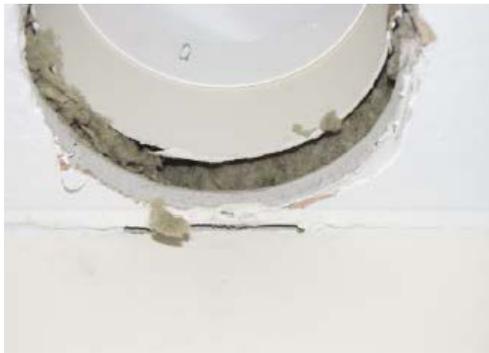
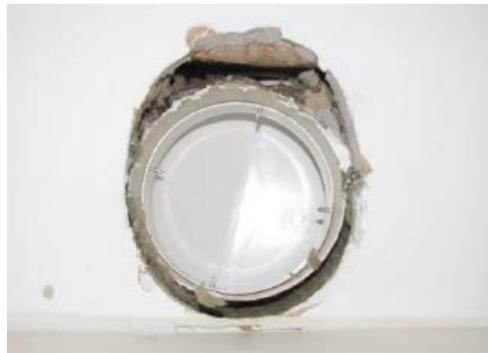
Figure 17  
Left - gap between duct end and ceiling  
Right - oversized cut outs in the plaster board

- Supply and extract valves found in the 'unlocked' position
- Ducts were too short hence the valves were not fully engaged with the duct resulting in significant airflow bypassing the valves and flowing directly into the ceiling void (Figure 17)
- Oversized cuts in the plaster board where the distribution valves were mounted (Figure 17)
- Most of the supply and extract terminals were not installed as specified in the drawings, with the supply terminals installed in position of the extract terminals and vice versa (Figure 18)
- Some ceiling terminals had been fitted too close to the wall which resulted in ineffective air distribution (Figure 15)

The MVHR unit is easily accessible and is easy to operate. However, the control is not intuitive and a simple User Guide would be useful. Furthermore, the system is not installed and commissioned properly. There is a large amount of leakage into ceiling voids due to the way the ceiling terminals have been installed.

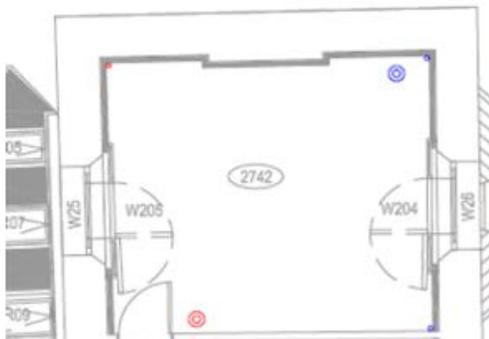
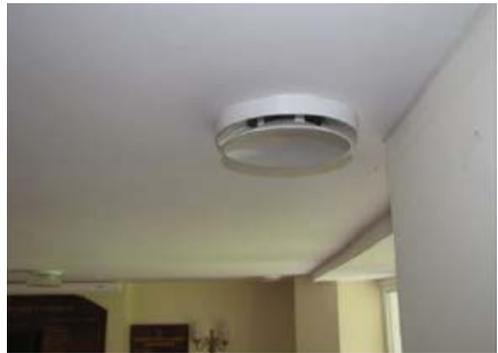
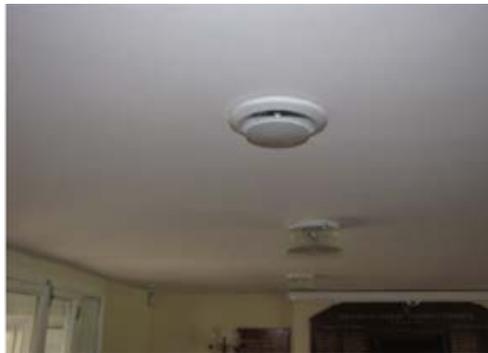
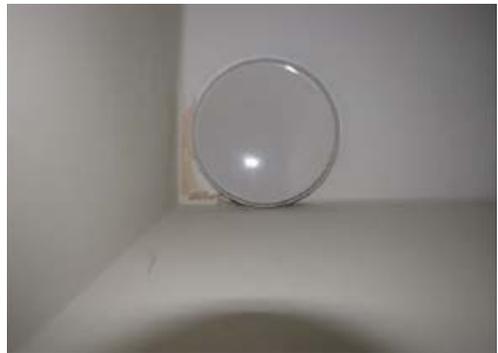
Figure 18  
 Top left – excerpt from installation drawing  
 Top right and bottom left – supply air valve used as extract valve and vice versa  
 Bottom right – terminal fitted too close to the wall

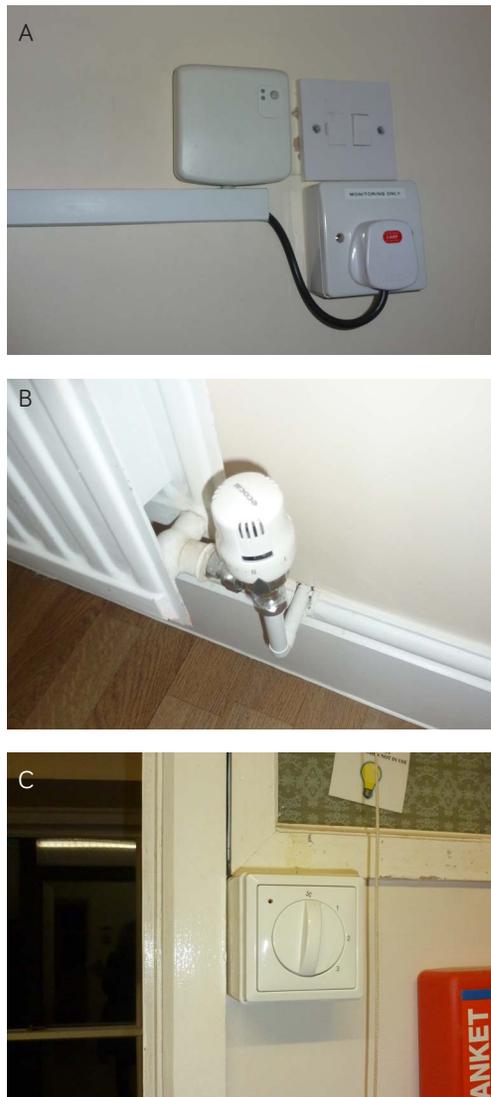
Figure 19  
 (A) Boiler control – not intuitive to use  
 (B) Radiator valves – easy to access and use  
 (C) MVHR boost – no labelling and no indication of system response

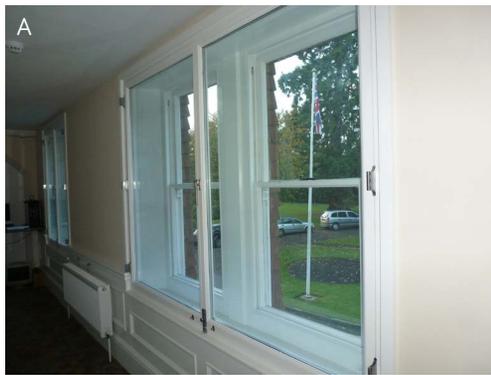
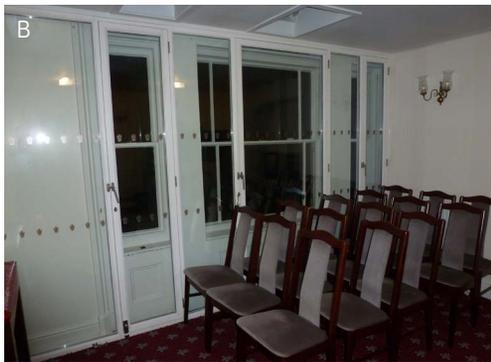
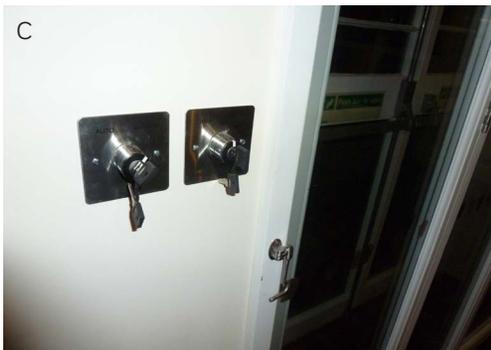
Figure 20

- (A) First floor windows – fully openable giving good access to original sash windows
- (B) Ceremony room windows – windows opening hindered by furniture
- (C) Electric window switches – the electric windows they control are not visible from the switch location hence no indication of system response
