**Low-energy, in-situ refurbishment and building performance evaluation of a historic town council building**

# Low-energy, In-situ Refurbishment and Building Performance Evaluation of a Historic Town Council Building

Professor Rajat Gupta  
Dr Adorkor Bruce-Konuah  
Adrian Kite  
Alex Towler  
Nicole Lazarus  
Sue Mackrell

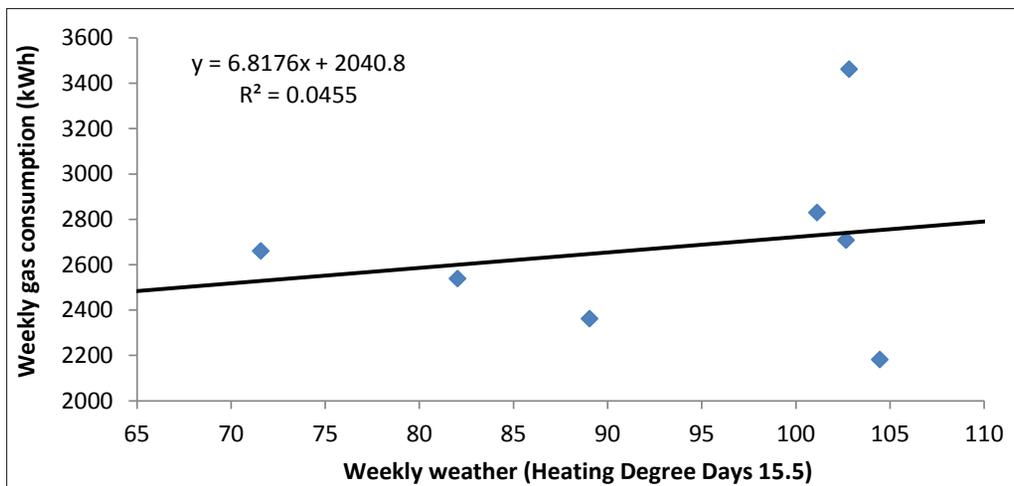
Figure 2  
Relationship between weekly gas consumption and heating degree days

An examination of the relationship between weekly gas consumption and heating degree days (HDDs) (Figure 2) showed that a one HDD increase resulted in 6.8kWh increase in gas consumption. The line of best fit also shows a poor level of control of the heating system as gas consumption only explains 4.6% of the variation in heating degree days. This is confirmed by the

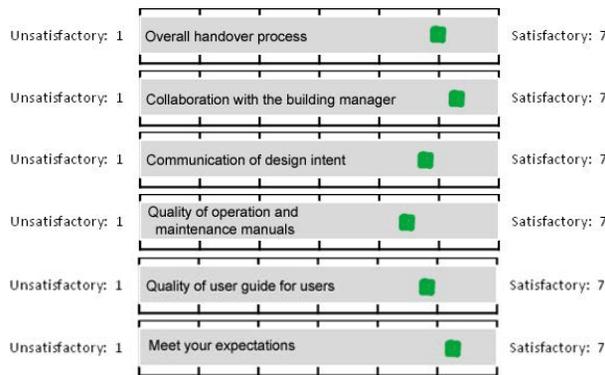
Figure 9  
Feedback on the handover process

Observations made in the BPE study showed that there was good communication between the designer and the building user and occupants understood the ventilation strategy well. However a review of the handover documentation revealed that there was no written information on the commissioning of the MVHR system and no information about a maintenance schedule. The Building manual was incomplete and there was no building logbook. Concerns were raised about the need for having a clear handover documentation (logbook, commissioning reports, operation and maintenance manuals and user guides) which is carefully organised and kept up to date. It

was found that a schedule for seasonal commissioning and maintenance of building services be put in place and highlighted in the user guide. Table 6 presents a summary of the findings from handover and Figures 9 and 10 shows the feedback given on the handover process and some images from the handover and training sessions respectively.

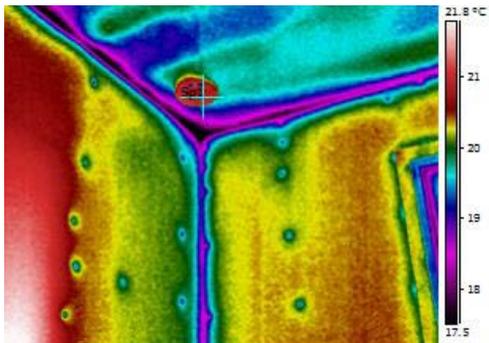
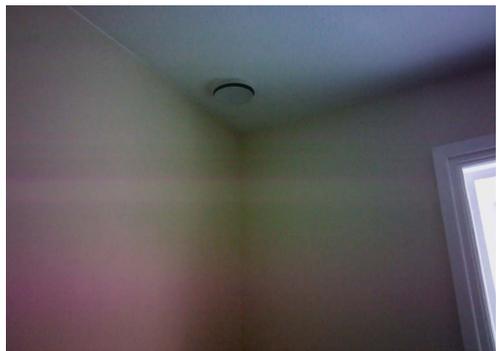
Figure 16  
Thermal image showing heat loss through the window (A) Pre refurbishment (B) Post refurbishment

images of the external wall taken during the pre-refurbishment study (Fig 16A) and the post-refurbishment study (Figure 16B). The internal temperatures recorded at the window are 14.7°C (external temperature is 24°C) and 9.7°C (external temperature is 23.2°C) in Fig 16A and Fig 16B respectively. This indicates that after the refurbishment, heat loss through the window has reduced compared to before the refurbishment due to the installation of the secondary glazing.

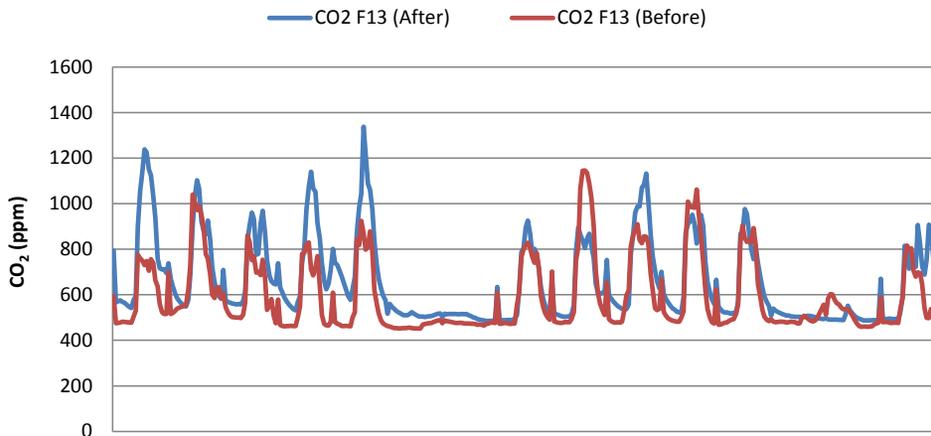
Figure 30 CO<sub>2</sub> concentration in room F13 before and after the refurbishment during winter (Before: Feb-13 - Mar-13 After: Feb-15-Mar-15)

A comparison between CO<sub>2</sub> concentrations in room F13 on the first floor before and after the refurbishment show that higher concentrations occurred after the refurbishment than before. During both periods concentrations remained below 1500ppm, indicating adequate ventilation (Figure 30). The number of occupants in room F13 remained unchanged before and after the refurbishment. The higher concentrations after the refurbishment were probably due to the installation of insulation and lower air permeability levels. This indicates the importance of provision of adequate ventilation when the building air tightness is increased.

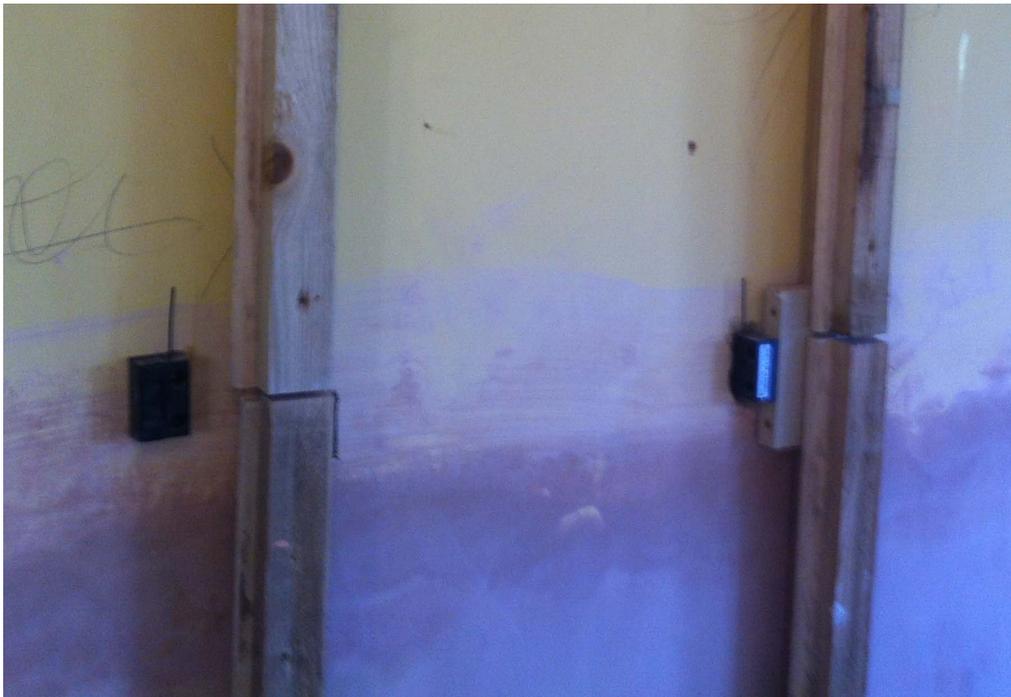
Figure 31  
Moisture sensors  
installed on the  
timber studs to record  
moisture content

monitoring system, sensors were installed to measure moisture content (Wood Moisture Equivalent (WME)) in the cavity construction formed behind the internal wall insulation and the timber studs at various locations (Figure 31). It is used to monitor the physical performance of behind the internal wall insulation and investigate if there was any risk of moisture related damage to the building fabric. Moisture build-up within the building fabric can result in mould growth and health risk to occupants as well as structural damage through rot.

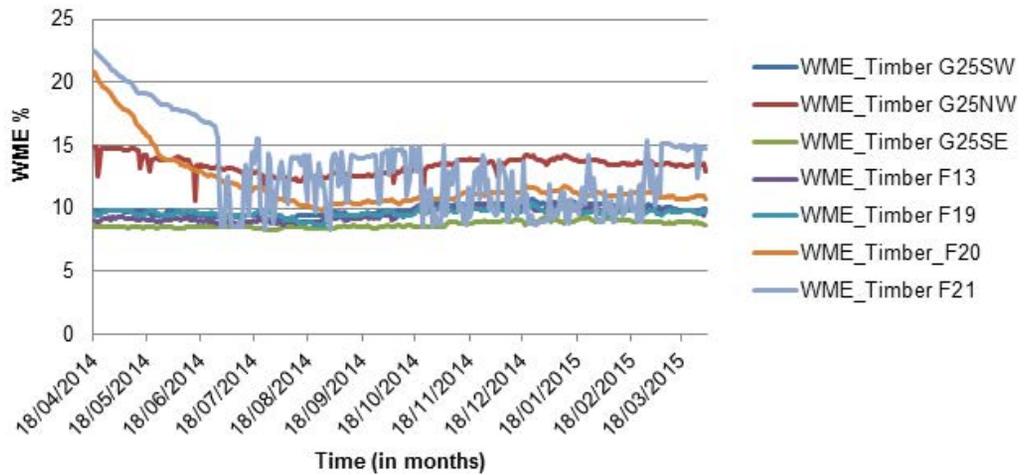
Figure 32 Wood Moisture Equivalent (WME) of the timber studs inside the internal insulated walls

As shown in Figure 32 moisture content of the timber studs reduced gradually from a maximum of 23% to below 16% over the first three months after the refurbishment and also remained relatively stable, well below 20% for the remainder of the monitoring period (dry rot thrives when humidity is over 90% and temperature is around

23°C. In a well maintained building, the moisture level in timber should not rise above 20% (Jenkins, 2008).
